Structural Study of Different Proposals for Reconstruction Methodology of Ottoman Citadel of Al-Faqeer at Al-ULA Governorate in KSA to Enhance its Structural Response and Safety Factor Against Earthquake

KEYWORDS: Al-Faqeer Citadel – Reconstruction - Structural Analysis – Diaphragm - Earthquakes.

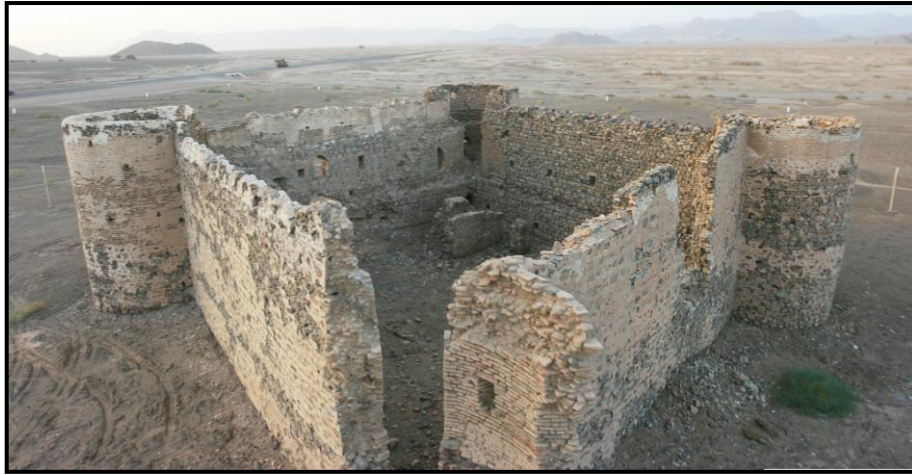
Plate (1): 3D Panoramic view of Al-Faqeer Citadel; shows the highly deterioration and destruction condition.

Plate (1) is a 3D-panoramic view of Al-Faqeer Citadel. It shows the remaining parts of the building which are the four façades, three towers of the four corner ones, and few of the interior walls. Most of the interior walls (almost all) and all wooden roofs had collapsed. Plates (2: a, b, c and d) show details of the high deterioration and destruction

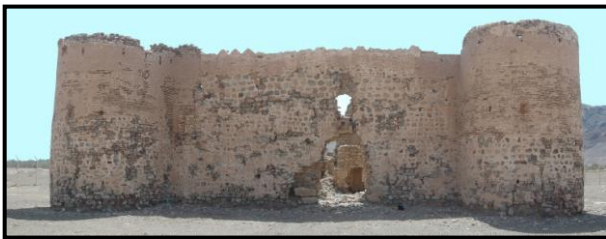
Plate (2-a): The N-W (main) façade.

Plates (2: a, b, c and d): The high deterioration and destruction conditions of the four façades of the citadel.

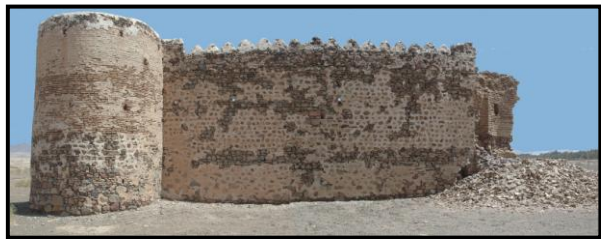
Plate (2-b): The S-W façade (collapse of South tower).

conditions of the four façades of the citadel. Plate (2-b) shows the S-W façade with the South tower which is partly (about 2/3 of it) collapsed. The tower ruins are still at its site.

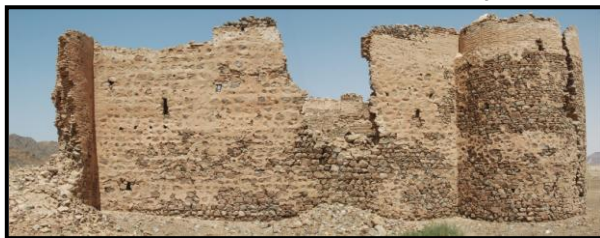
Plate (2-c): The S-E façade destructions.

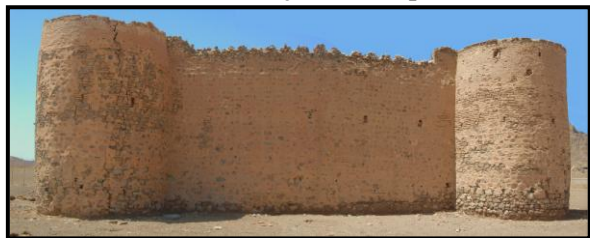
Plate (2-d): The N-E façade.
