# Nanostructural Changes in the Cell Membrane of Gamma-Irradiated Red Blood Cells

**Abstract** The effect of gamma radiation on the ultra-structure of the cell membranes of red blood cells has been probed using a powerful tool, namely, atomic force microscopy. We used mice erythrocytes as a model. Blood samples withdrawn from mice were gamma-irradiated using a <sup>60</sup>Co source unit with doses of 10,15,20,25 and 30 Gy. Structural changes appeared in the form of nanoscale potholes, depressions and alterations of the cell membrane roughness. The roughness of the cell membrane increased dramatically with increasing doses, although at 10 Gy, the cell membrane roughness was less than that of normal red blood cells (controls). Therefore, such modifications at the nano-scale level may affect the biophysical properties of membranes, resulting in impairment of their function.

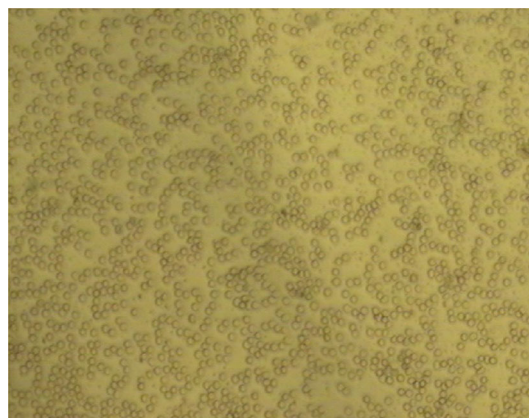
**Fig. 1** An optical image of RBCs distributed on a glass coverslip

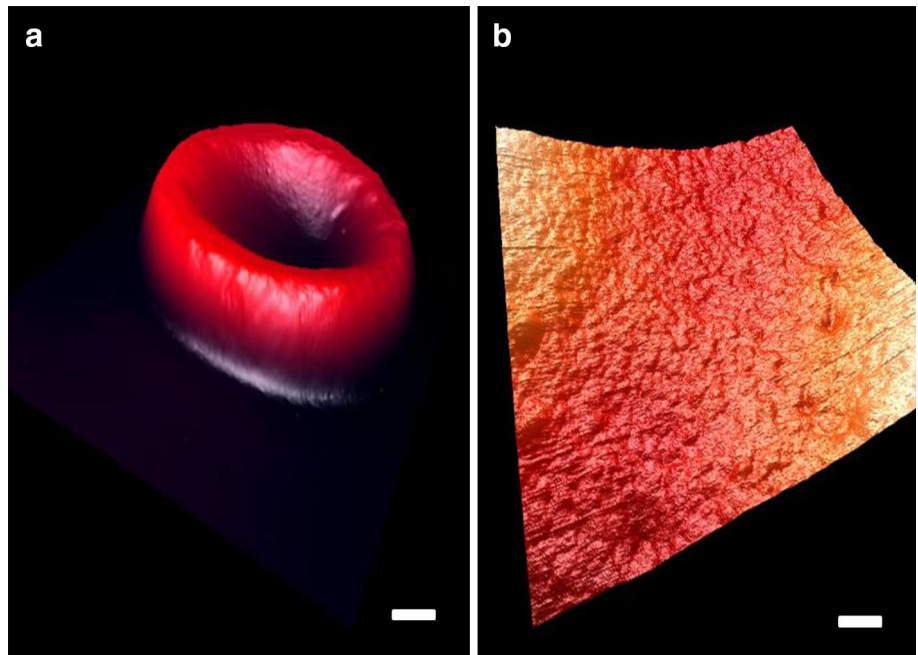
The morphological properties of non-irradiated RBCs (controls) have been investigated by means of AFM. Figure 2a displays a typical three-dimensional topographical AFM image of non-irradiated erythrocyte. At a small scan size ( $1.2 \mu\text{m}$  square scanning), the ultrastructure of the membrane surface of the RBC appeared smooth and uniform (Fig. 2b). The overall morphologies of irradiated RBCs are similar to those of non-irradiated ones, and no considerable changes in their morphology can be reported. However, by zooming in on the surface using a smaller scan size (e.g.,  $\sim 1 \mu\text{m}$  square scanning), clear differences between cells can be revealed; nano-scale potholes and pores appeared on the membrane surface, and alterations in the roughness of the surface, emphasizing the role of irradiation in alternating the structure of the cell membrane, were seen.

**Fig. 2** **a** A three-dimensional AFM image of a single non-irradiated RBC; *scale bar* 1.5  $\mu\text{m}$ . **b** Ultrastructure of the RBC membrane, *scale bar* 200 nm

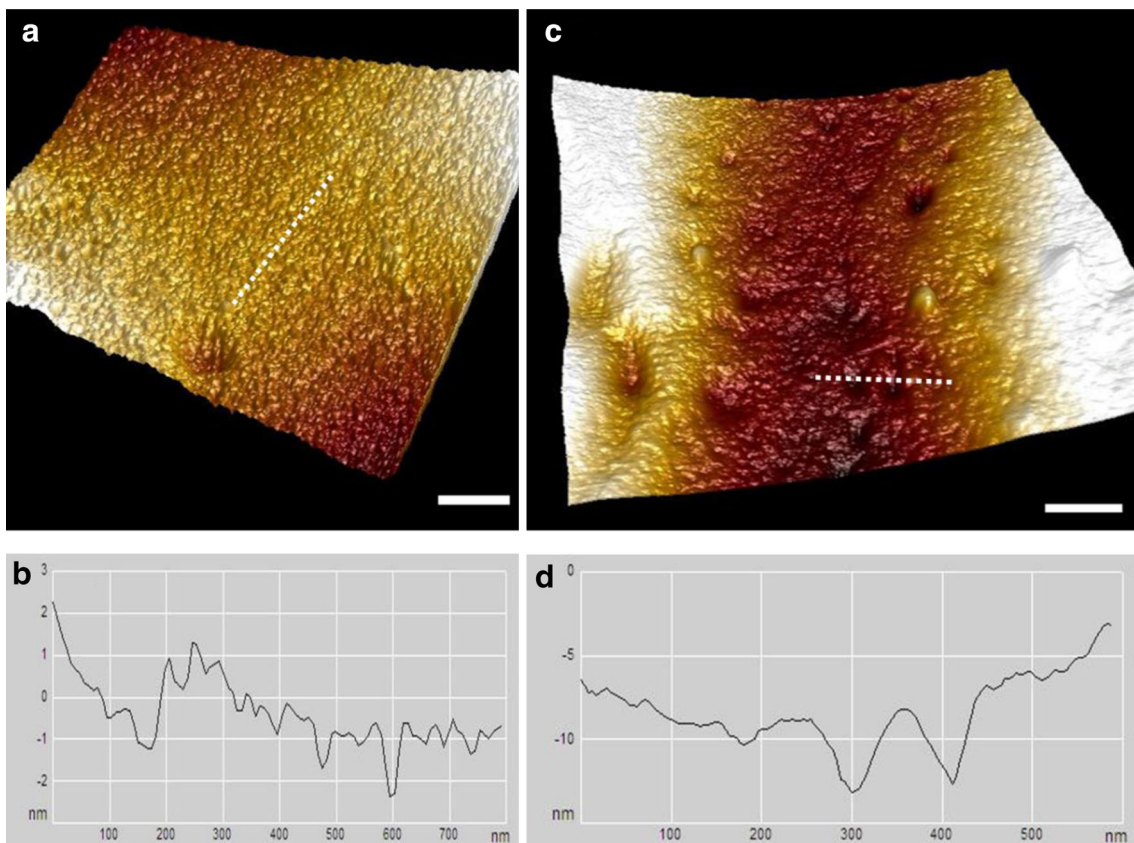
In the samples irradiated at 10 Gy, the ultrastructure of the membrane surface of the RBCs did not show major differences compared with non-irradiated RBCs (Fig. 3).

**Fig. 3** **a** Ultrastructure of an RBC membrane irradiated at 10 Gy. **b** The line profile of the image along the *dashed line* in **(a)**. **c** Ultrastructure of RBC membrane irradiated at 15 Gy; few potholes

and depressions on the cell membrane can be observed. **d** The line profile of the image along the *dashed line* in **(c)**. *Scale bar* 200 nm

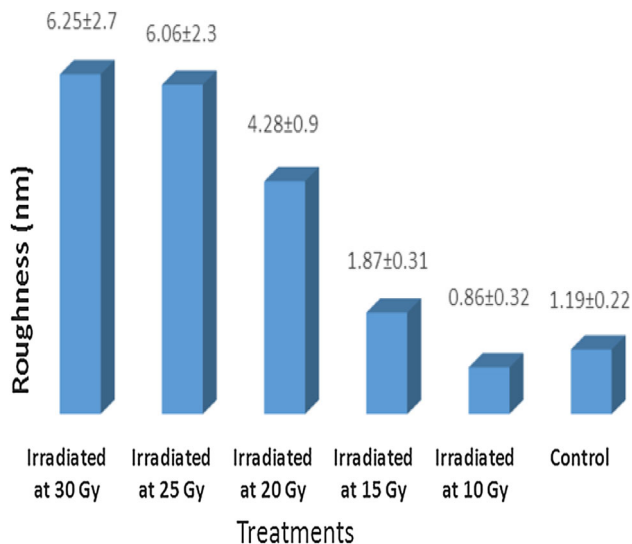
**Fig. 4** The cell membrane roughness of RBCs after irradiation. RBCs were irradiated at different gamma doses. The mean of the roughness (nN)  $\pm$  standard deviation ( $n = 100$ ) of RBC membrane for irradiated and non-irradiated cells

However, variations were observed in the cell membrane roughness. The samples irradiated at 10 Gy showed a significant decrease in the surface roughness by 30 % compared to the controls (Fig. 4). The roughness decreased from  $\sim 1.2$  to 0.86 nm. For the samples irradiated at doses higher than 10 Gy, a remarkable increase in the surface roughness was observed. For example, the surface roughness of RBCs irradiated at 25 and 30 Gy is approximately five times higher than that of the controls ( $\sim 1.2$  nm).

We also observed an increase in the cell membrane roughness as a function of irradiation dose. This finding provides evidence that ROS are capable of triggering structural deficits in the lipid bilayer and cytoskeleton of RBC membranes. However, RBCs have the ability to resist such deformation and recover. Benderitter et al [32] demonstrated that the level of lipid peroxidation increased in the hours after radiation exposure but was not observed after 3 days post-irradiation. However, the recovery system may repair damage caused by ROS faster than was previously thought. At a dose of 10 Gy, no morphological alterations or geometrical changes have been observed compared to the controls, but the value of membrane roughness was smaller than that of the control. The reason for the decrease in the surface roughness is not yet clear, but it may be an attempt to reorganize the cell membrane components to maintain the integrity of the surface. We hypothesize that at 10 Gy, relatively small and unstable nano-pores were initially formed that were then obliterated by a recovery mechanism within the cells, which occurred a few hours after irradiation. However, the level of damage induced by doses higher than 10 Gy could be beyond the repair ability of the cell, at least at the nano-scale level.

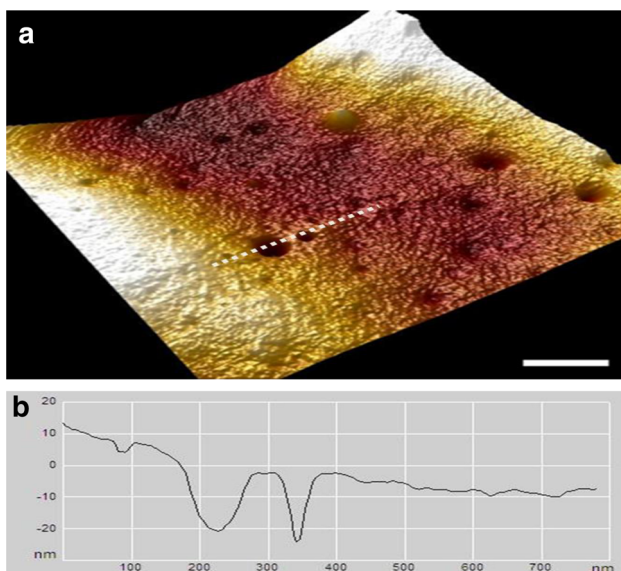
**Fig. 5** **a** Large, deep potholes are observed on the membrane of RBCs irradiated at 20 Gy. **b** The line profile of the cell membrane in (a) along the dashed line. Scale bar 200 nm

In Fig. 5, the RBCs exposed to 15 Gy showed nontrivial ultrastructural alterations; few small nano-pores appeared on the membrane surface. The depth of the pores varied between 3 and 8 nm. The number of potholes, their depth and the surface roughness increased at higher doses (20, 25 and 30 Gy) (Figs. 5, 6). An increase of the gamma radiation dose beyond 15 Gy dramatically changed the ultrastructure of the RBC surface membrane. The size of the potholes and the roughness of the cell membrane surface became more prominent. As seen in Fig. 6c, another noteworthy alteration is the appearance of many protuberances on the membrane surface of the irradiated erythrocytes at doses of 25 and 30 Gy. There are large protrusions or blebs with an average height on the order of 3–6 nm and an approximate diameter of 100–200 nm.

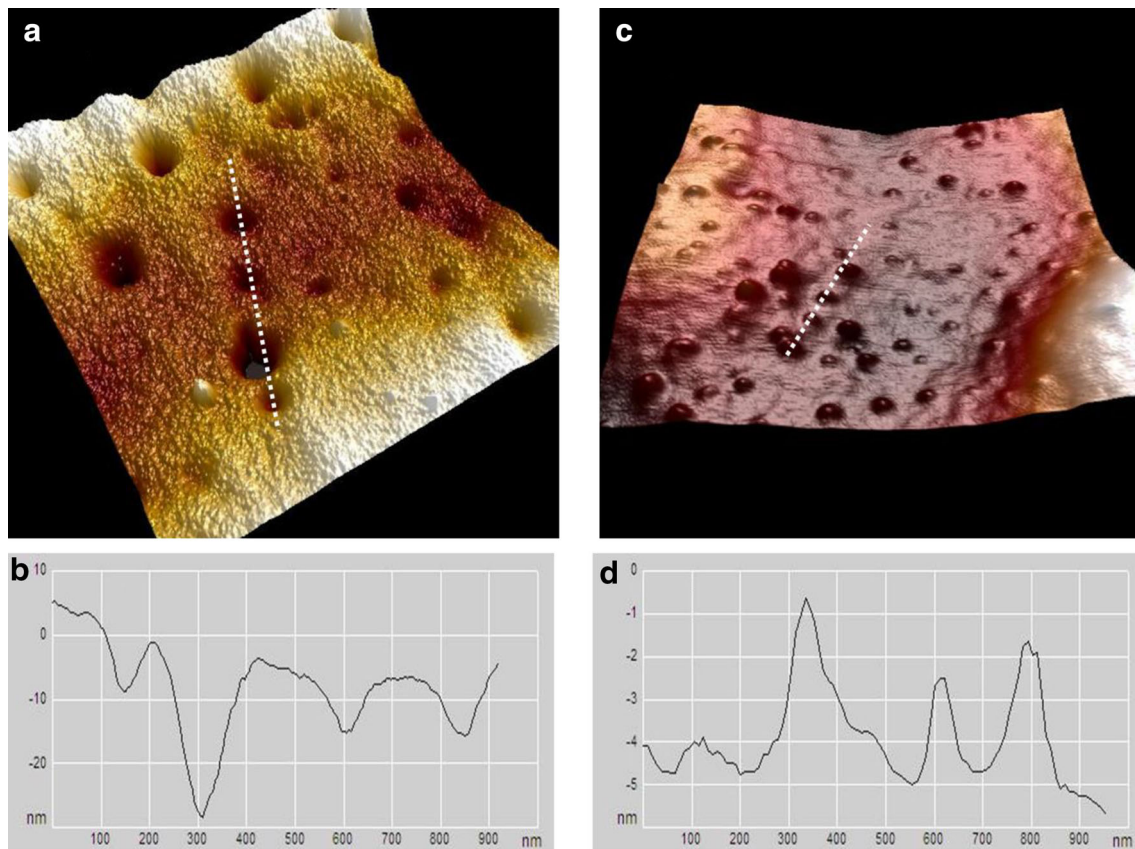
**Fig. 6** Ultrastructure of RBC membranes irradiated at 25 and 30 Gy. The effect of irradiation is manifested as large potholes (a) or as blebs (c) on the membrane. **b** The height profile along the *dashed line* in (a). **d** The height profile along the *dashed line* in (c)
